# Killin Wetlands Access Master Plan

Washington County, Oregon

December 2015

Nevue Ngan Associates, Landscape Architects

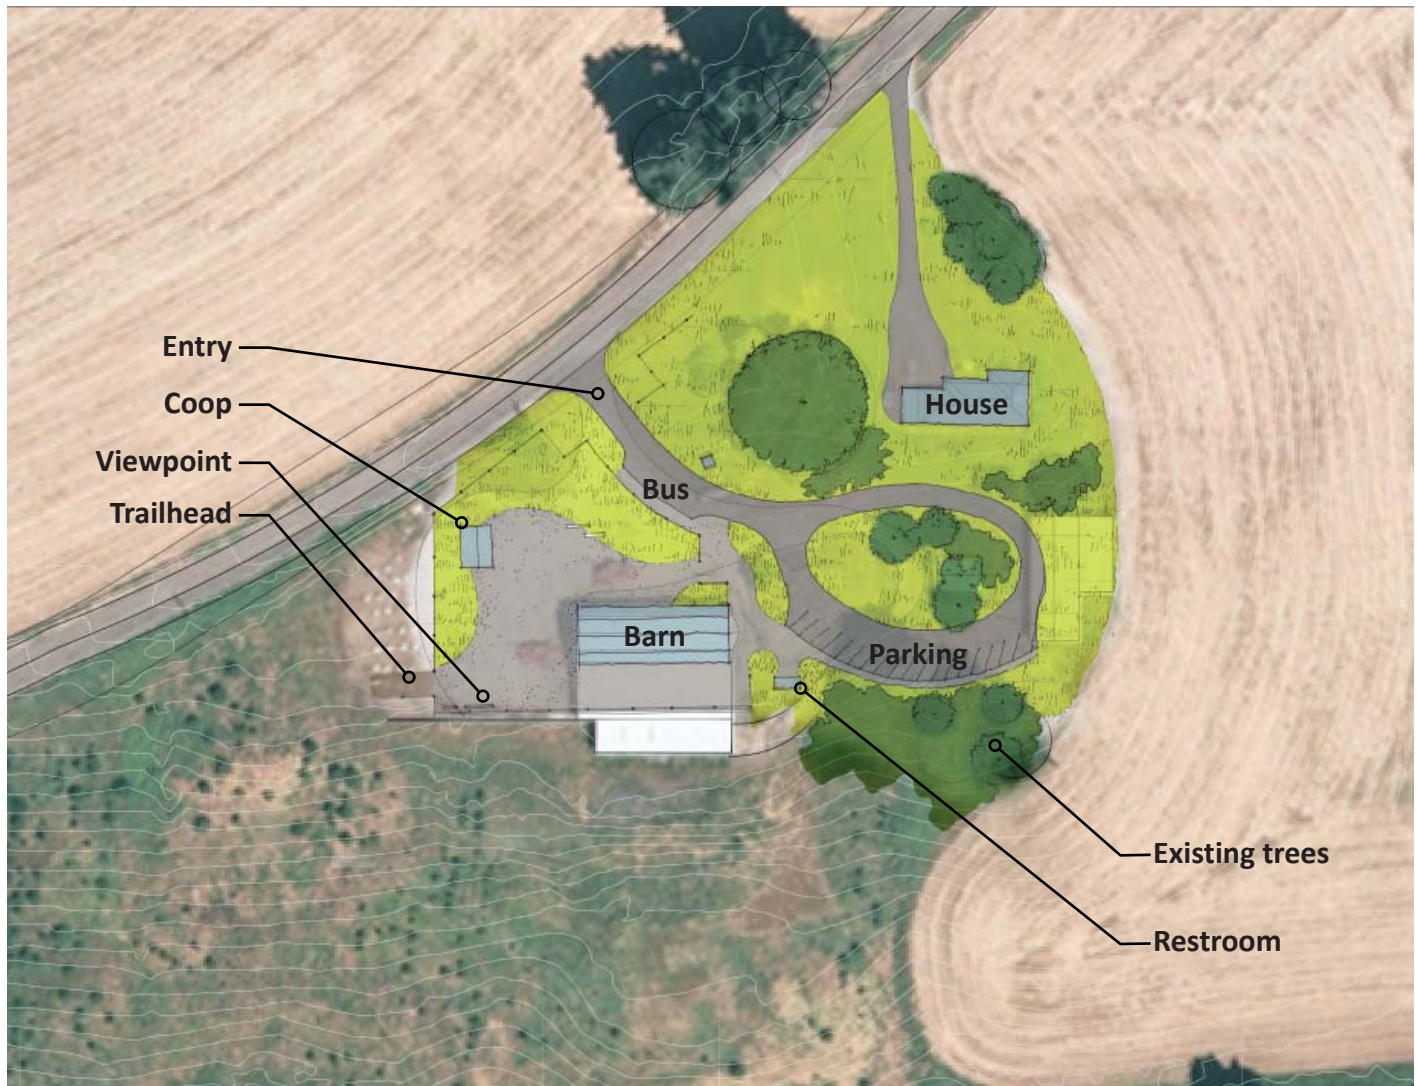
### Alternative 1: One Way Loop

- Maintains the existing residence
- Loop road gets fairly close to home
- Need to relocate chicken coop
- Potentially impacts fir trees on the south side of the parking lot
- Limited opportunities for expansion of parking

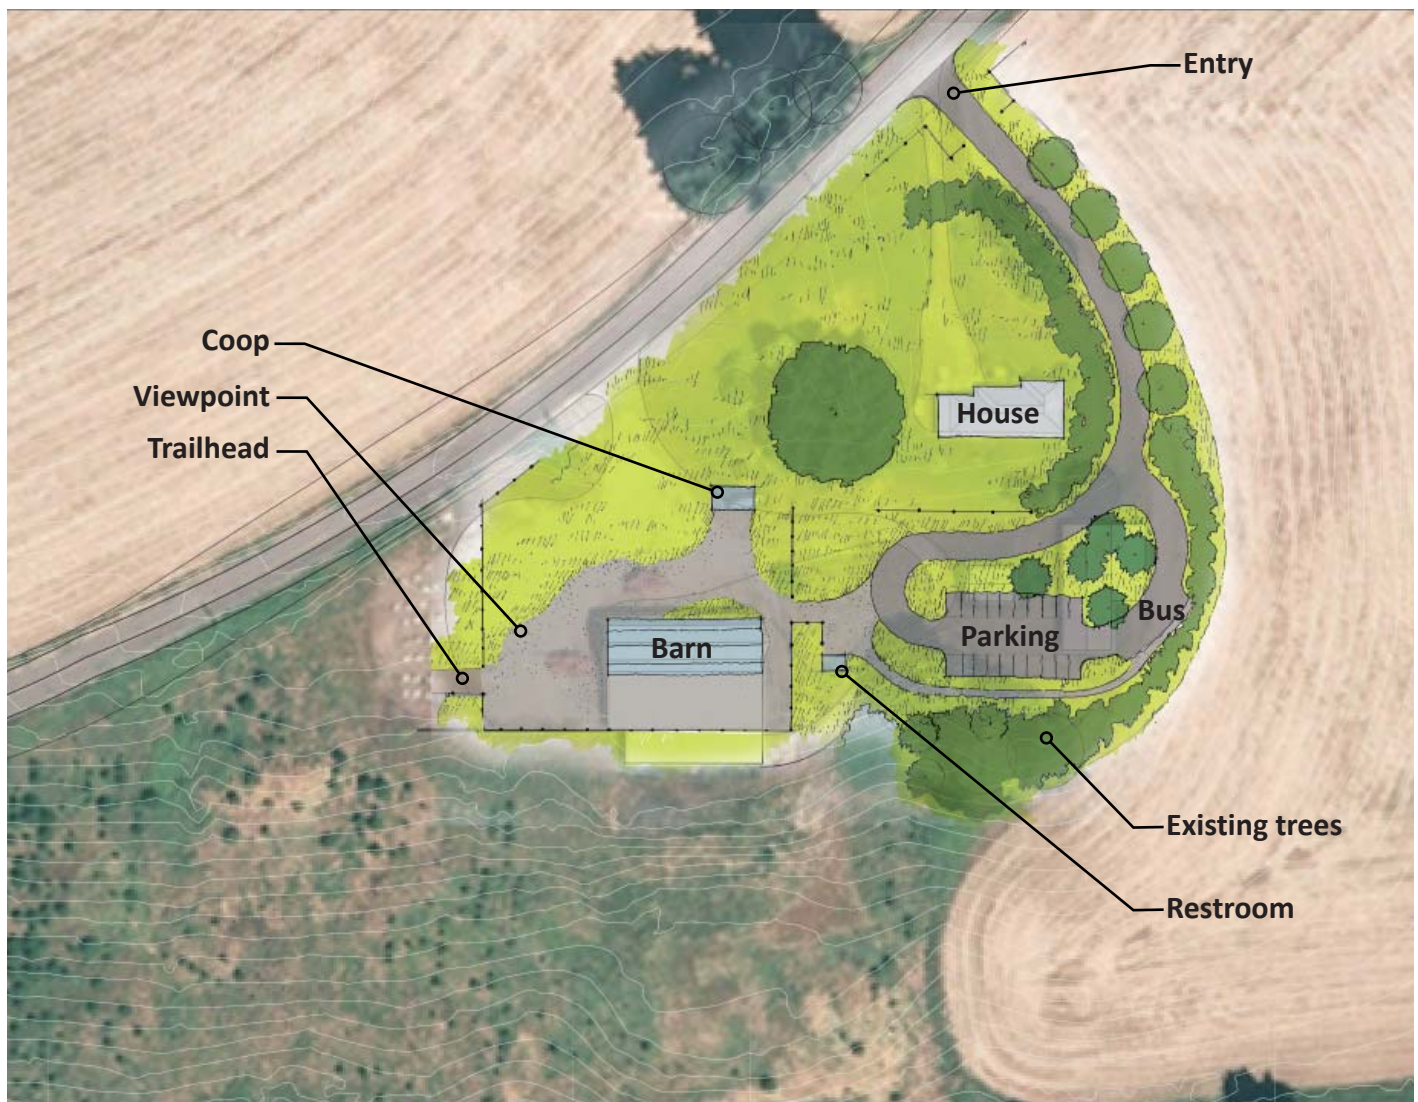
**Alternative 2: Entry Road adjacent to field**

- Opportunity to maintain the existing residence
- Entry road may require cultivated field area to be adjusted
- Limited opportunities for expansion of parking

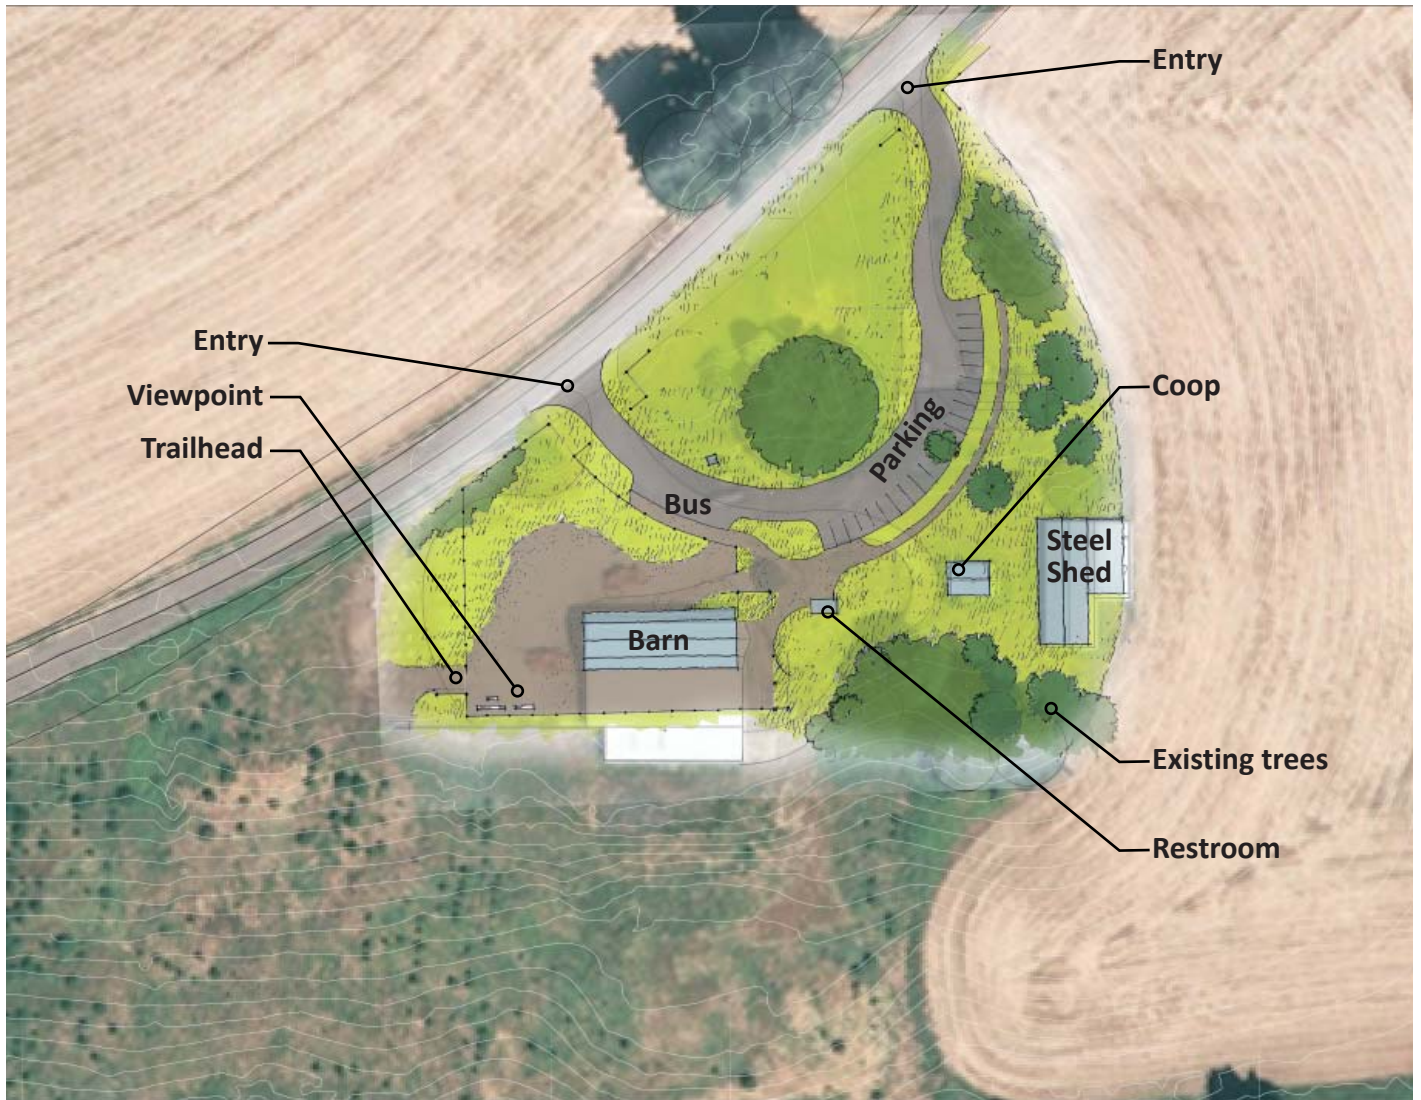
**Alternative 3: Loop Entry Road**

- Removes the existing residence
- Pedestrians circulation along the edge of parking area
- Provides narrower drive aisle

The preferred alternative is the loop entry road. This alternative was reviewed and selected by Metro’s Parks and Nature Department staff because it is simple, easy to expand as demand increases, provides visitors clear orientation to the entry, improves visibility and safety, and protects site resources. The barn naturally becomes a favorable location for day-use facilities, trailheads, and a small parking lot. The goal is to keep most improvements within the area that already houses the barn in order to maintain a “light touch” on the landscape and habitat. Natural resources and habitat restoration efforts will be focused on sensitive areas, such as the unique wetland and surrounding upland areas (see Appendix C).

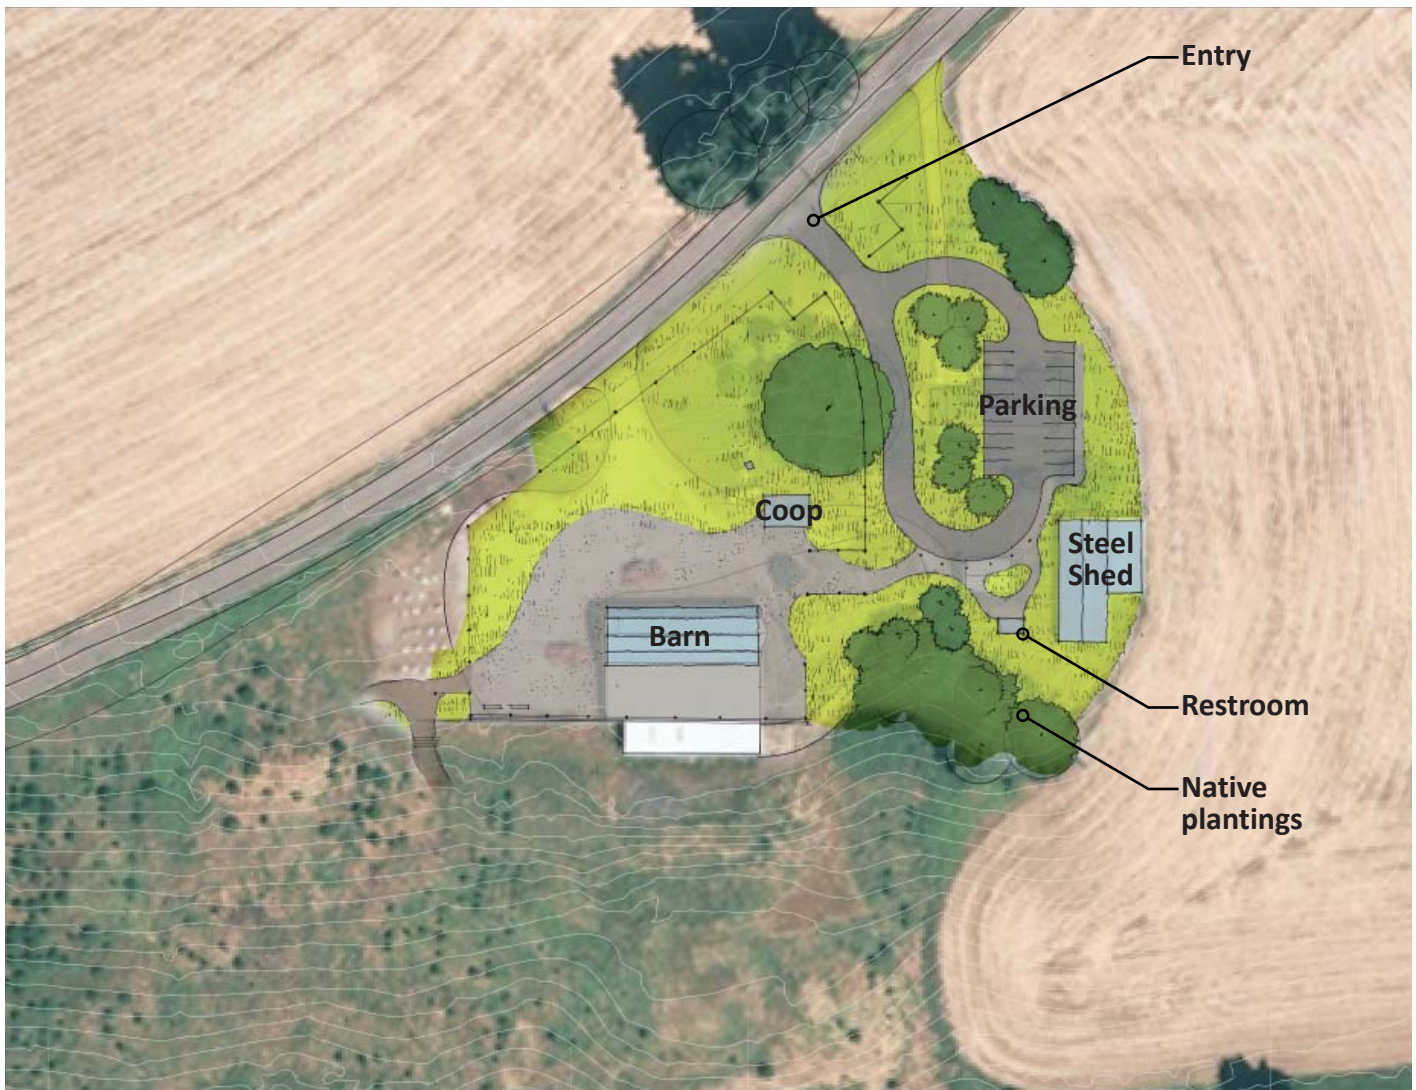
**Alternative 4: Maximizes open space by the barn**

- Removes the existing residence
- Moves parking to the east, adjacent to the farm
- Relocates the coop building
- Limited opportunities for expansion of parking

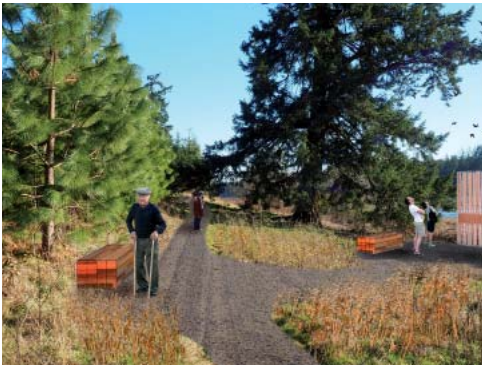
*Trail and blind illustration*

Trailheads are located at the east and west sides of the barn. Trails lead to viewing destinations which are sited on spurs off the main trails. The destinations are intended to have casual seating, and natural or structured blinds. The destinations are located to disperse visitors and give the best access to some of the more desirable viewing areas. Future planting along the trails will be grouped to accent views and screen visitors from the overlook. Additional vegetation between the trails and the wetland may help prevent birds from flushing from the wetland due to visitor use.

Trails are designed to reasonably accommodate visitors that may have limited mobility. Because of the topography, there may be some higher challenge trail lengths with steeper grades. Overall the intent is to keep the trail tread at or below 5%. Most of the trails are soft surface and are between 3 and 4 feet wide.

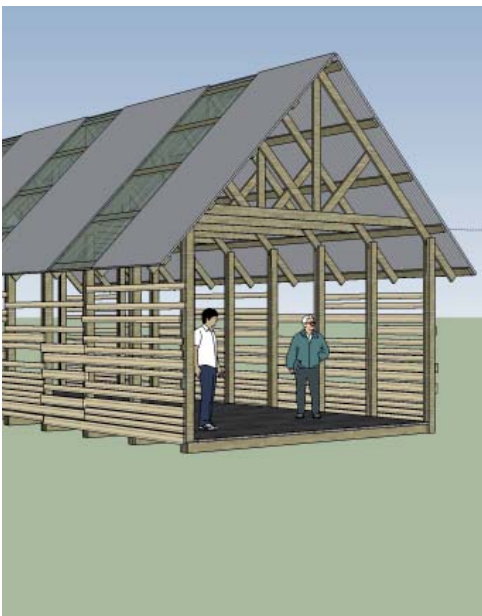
*Shelter on terrace illustration*

A shelter is shown at the edge of the lower terrace. The shelter is sited to the east of the barn out of direct line of site from the barn overlook. Planting on the back side of the shelter will diminish its view from the barn overlook. The shelter could provide an opportunity for groups or classes to gather in a place away from the main entry.

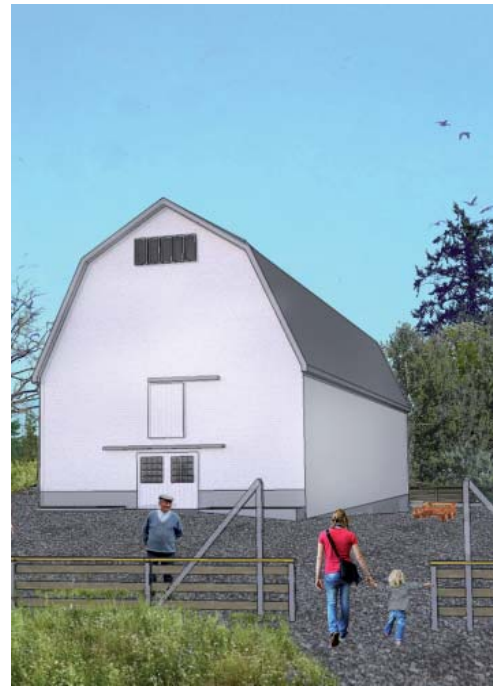
*Barn modification concept illustration*

Public access will require that some improvements to secure the barn are completed. Generally this will involve securing the doors, fixing siding and windows and determining a way to secure the open hay racks on the south side of the barn. Additional concepts for phased barn improvements access and interpretation are included in the architectural study in the Appendix.
